BUILDING AND PEST INSPECTION REPORTS

Pre-Purchase Inspections

STANDARD DETAILS FOR BOTH BUILDING AND TIMBER PEST INSPECTIONS

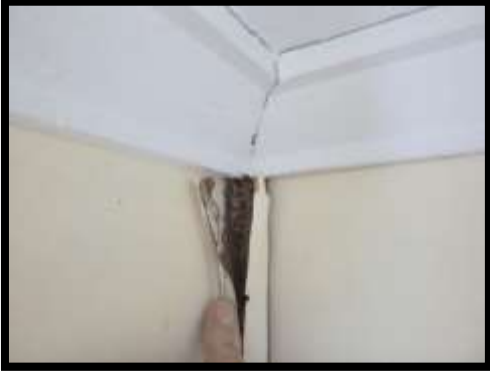
Areas Inspected	Location	Type of Defects (E.g.: Damage, Distortion, Warping, Twisting, Dampness, Operational etc.)	Description of Defect/ Safety Hazard	Significance of the Defect. Recommended Action. (Duty to Warn) (Also refer to Important Advice Section)
1.01 Ceilings	Bedroom	Damp related	There is mould on the ceiling. Recommend treating with an anti-mould cleaner.	Recommend seeking further advice from a licensed & practising tradesman.
1.02 Walls	Front bedroom	Damage	There is termite damage to timber trims in corners of the walls. Repairs are required.

In general	Distortion	There is settlement cracking to the wall sheets.	Recommend seeking further advice from a licensed & practising tradeperson.
1.03 Timber Floors				No major defects or safety hazards found, at the time of this inspection.

Recommend seeking further advice from a licensed & practising tradesperson.

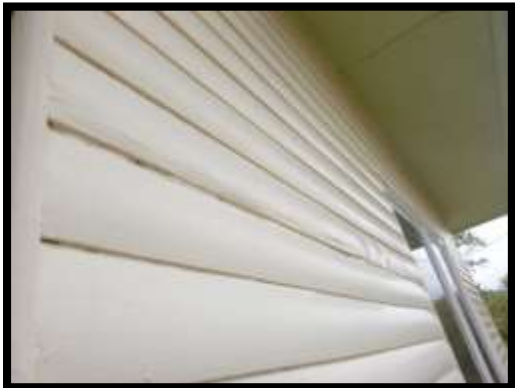
Areas Inspected	Location	Type of Defects (E.g.: Damage, Distortion, Warping, Twisting, Dampness, Operational etc.)	Description of Defect/ Safety Hazard	Significance of the Defect. Recommended Action. (Duty to Warn) (Also refer to Important Advice Section)
2.01 Walls	Front foundation wall		Refer to section 7.	
2.02 External Cladding	Front bedroom wall	Damage	<p>There is termite damage to weatherboards. Repairs are required.</p>

Recommend seeking further advice from a licensed & practising tradesperson.

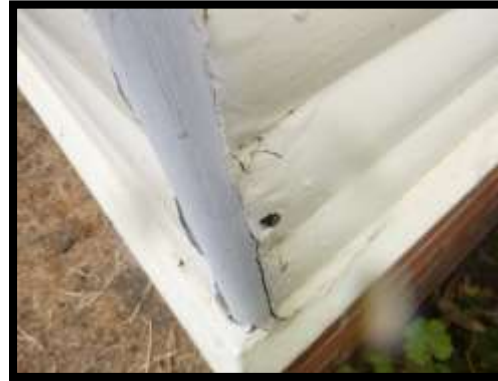
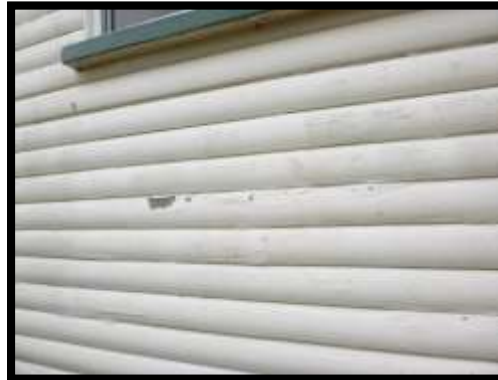
Front bedroom	Material deterioration	There is wood decay to weatherboards at the corner. Repairs are required.	Recommend seeking further advice from a licensed & practising tradesperson.
	In general	Material deterioration	The paint is blistering and peeling.	Recommend seeking further advice from a licensed & practising tradesperson.
2.03 Doors and Windows	Laundry	Damage	Repairs are required to door keeper.	Recommend seeking further advice from a licensed & practising tradesperson.
2.04 Timber or Steel Frames and Structures	NOT APPLICABLE

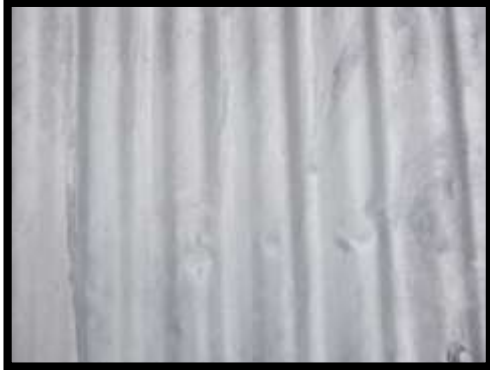
Areas Inspected	Location	Type of Defects (E.g.: Damage, Distortion, Warping, Twisting, Dampness, Operational etc.)	Description of Defect/ Safety Hazard	Significance of the Defect. Recommended Action. (Duty to Warn) — (Also refer to Important Advice Section)
3.01 Roof	In general	Material deterioration Damage	Some lead heads are coming off the roof fixing nails and should be replaced. There is hail damage to roof sheets.

Recommend seeking further advice from a licensed & practising tradesperson. -----
3.02 Skylights, Vents and flues				No major defects or safety hazards found, at the time of this inspection. Both fire boxes/fireplaces need to be burning fuel to test if the units work correctly. This test is outside the scope of this inspection and it is recommended that you have these units inspected and tested for peace of mind before purchase.

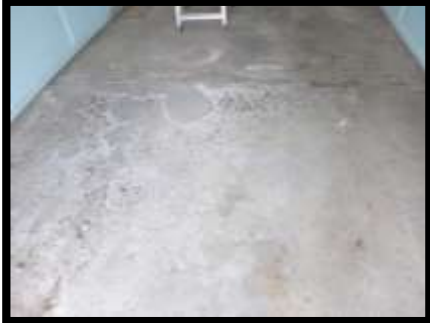
Areas Inspected	Location	Type of Defects (E.g.: Damage, Distortion, Warping, Twisting, Dampness, Operational etc.)	Description of Defect/ Safety Hazard	Significance of the Defect. Recommended Action. (Duty to Warn) (Also refer to Important Advice Section)
6.01 Car Accommodation	Garage	Distortion	The concrete floor is cracked and the surface has deteriorated.

Recommend seeking further advice from a licensed & practising tradesperson.
6.02 Detached Laundry	Downstairs	Distortion Installation	The concrete floor is cracked.

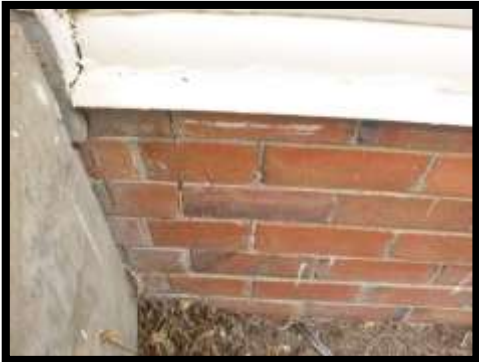
7.01 Concrete Slabs	NOT APPLICABLE		
7.02 Suspended Concrete Slabs	NOT APPLICABLE		
7.03 Masonry Walls	Front brick foundation wall	Serviceability	Cracking/movement was detected to brickwork/masonry walls. Although the cracking/movement appears to be serviceable, from the visual inspection carried out on the day & may be due to settlement, a further investigation from a licensed & suitably experienced Structural Engineer would be required to ascertain if further cracking/movement would be likely to occur. (Refer to section on cracking of building items on page 18). The installation of expansion joints in the brick work can also assist in allowing the wall to move when settlement or, excess wet or dry periods occur.

Where is the cracked Area?	Detailed Photo of Crack	Width and Length of Crack (Approximately)
Next to front stairs

W: Hairline L: Various
Under bedroom, RHS

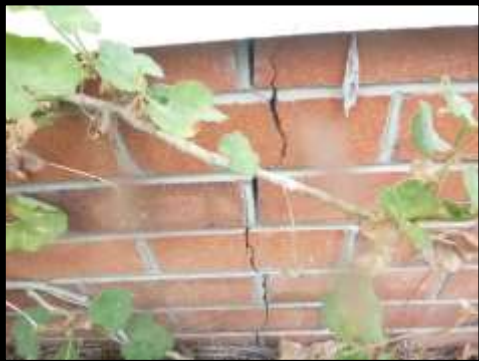
W: 5mm L: 700mm

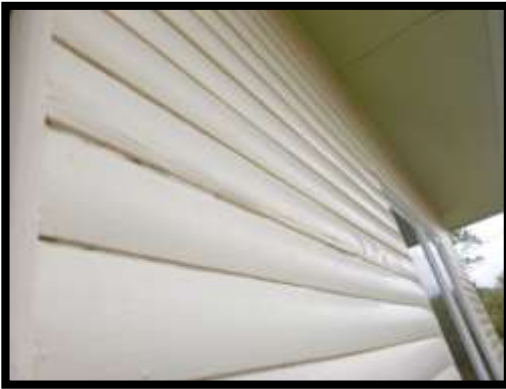
Photo 1

2.3 Visible evidence of subterranean termite workings and/or damage was found.Where workings and/or damage was found, it was in but not necessarily limited to the following areas: Weatherboards at front of house (Photo 1), Timber trim in corners of bedroom walls (Photo 2), Timber located in subfloor (Photo 3).
