BUILDING AND PEST INSPECTION REPORTS

Pre-Purchase Inspections

STANDARD DETAILS FOR BOTH BUILDING AND TIMBER PEST INSPECTIONS

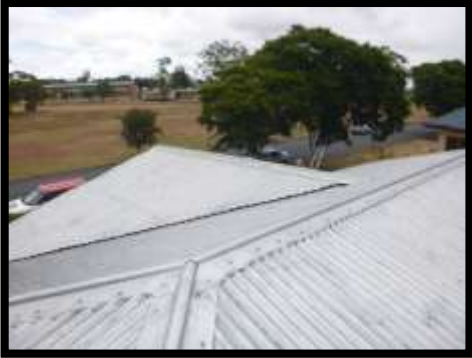
3.03 Valleys, Hips & Ridges

<p>No major defects or safety hazards found, at the time of this inspection.</p>
3.04 Guttering	In general	Material deterioration	<p>There is rust scale to the roof gutters. Rust treatment is required to prevent further deterioration.</p>	<p>Recommend seeking further advice from a licensed & practising tradesperson.</p> <p>Recommend a Plumber inspect and detail the requirements to ensure that the gutters are functional and adequate for the situation.</p>

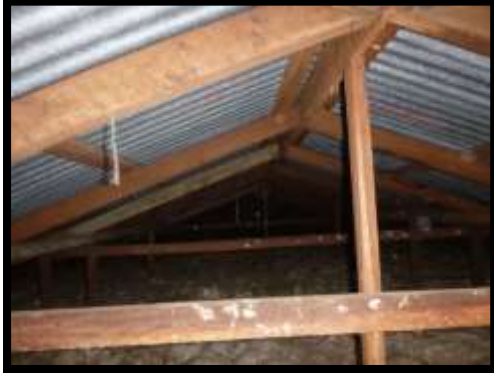
No major defects or safety hazards found, at the time of this inspection.
4.02 Roof Covering				No major defects or safety hazards found, at the time of this inspection.
4.03 Insulation				No major defects or safety hazards found, at the time of this inspection.
4.04 Sarking	NOT APPLICABLE			
4.05 Party Walls	NOT APPLICABLE			
4.06 Other	Bracing and Tie downs Man-hole			No major defects or safety hazards found, at the time of this inspection. No major defects or safety hazards found, at the time of this inspection.

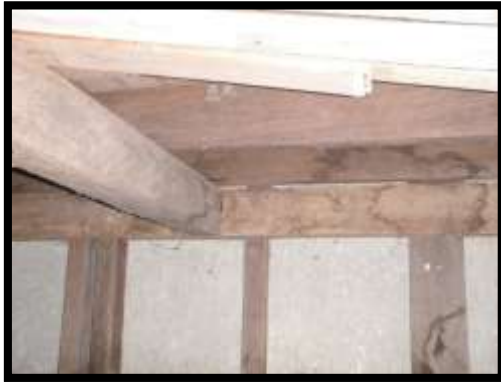
Areas Inspected	Location	Type of Defects (E.g.: Damage, Distortion, Warping, Twisting, Dampness Related, Operational etc.)	Description of Defect/ Safety Hazard	Significance of the Defect. Recommended Action. (Duty to Warn) (Also refer to Important Advice Section)
5.01 Timber Floors	Joists Bearers	Installation	<p>Recommend installing 90°angle brackets to the joins in the bearers that are not supported correctly by the timber stumps, or masonry piers.</p>

<p>No major defects or safety hazards found, at the time of this inspection.</p> <p>Recommend seeking further advice from a licensed & practising tradesperson.</p>
